CLOSE CALL/HAZARD REPORT

MAYDAY EVENT / COLLAPSE
10801 WINDCLOUD CT
JUNE 2, 2006

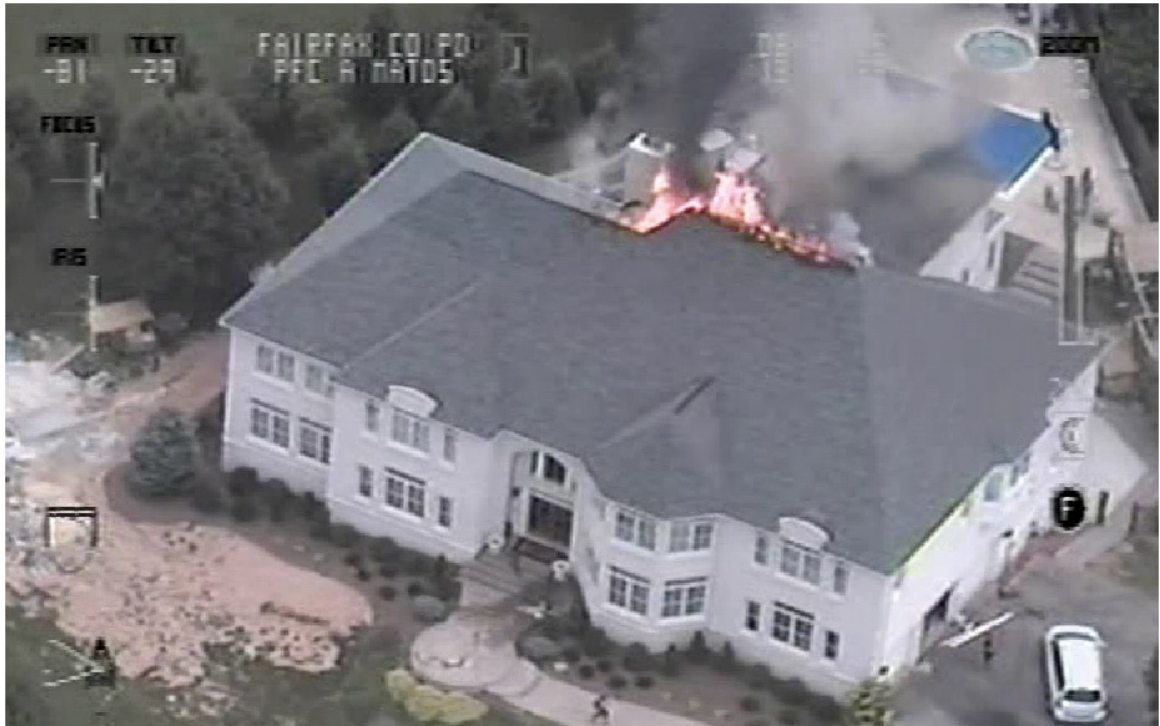
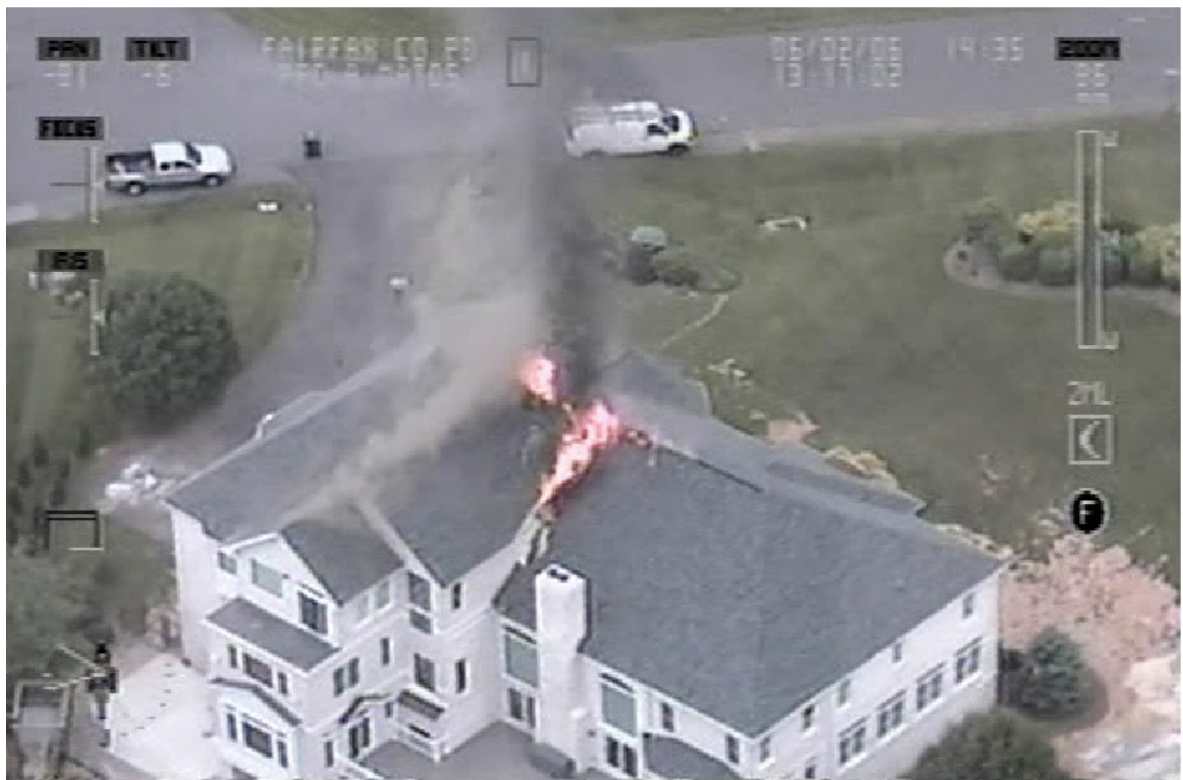
Views of sides A and C from Fairfax County Police Helicopter 'Fairfax One'. Fairfax One arrived overhead of the incident with their camera on approximately 5 minutes prior to the arrival of BC402 and F434.

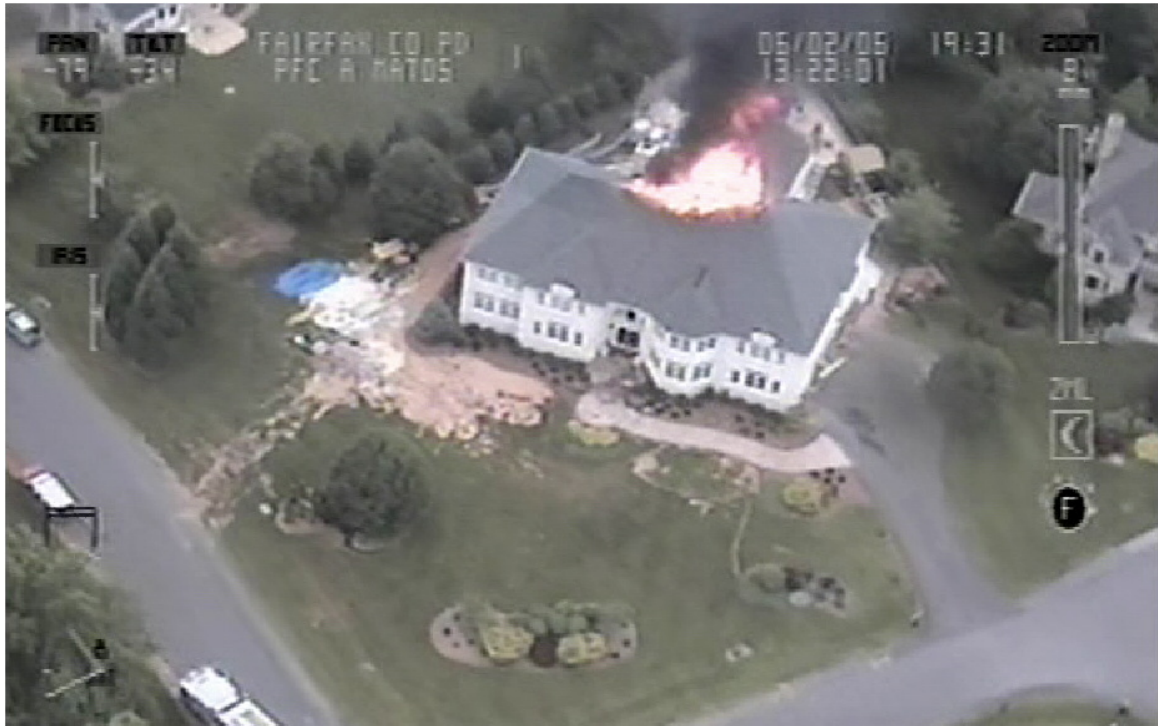
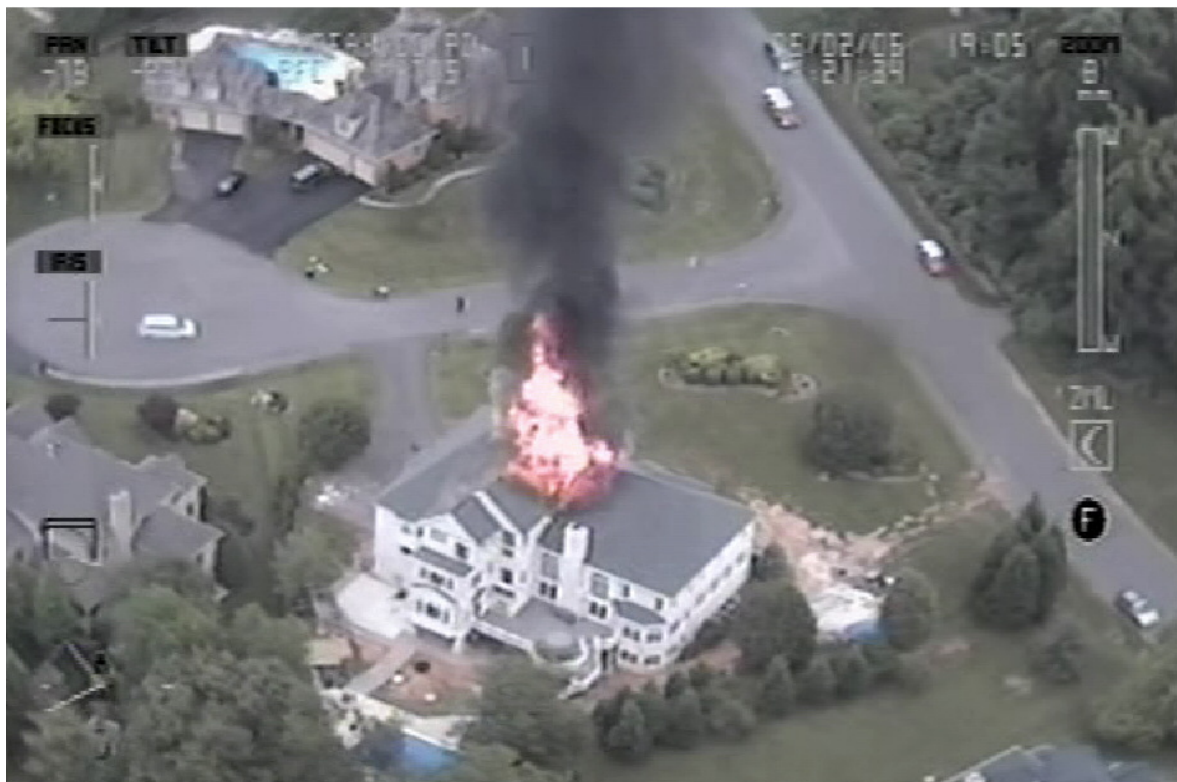
Views of sides A and C from Fairfax County Police Helicopter 'Fairfax One' as BC402 and E434 arrive on the scene. Fairfax One has been overhead for approximately 5 minutes.

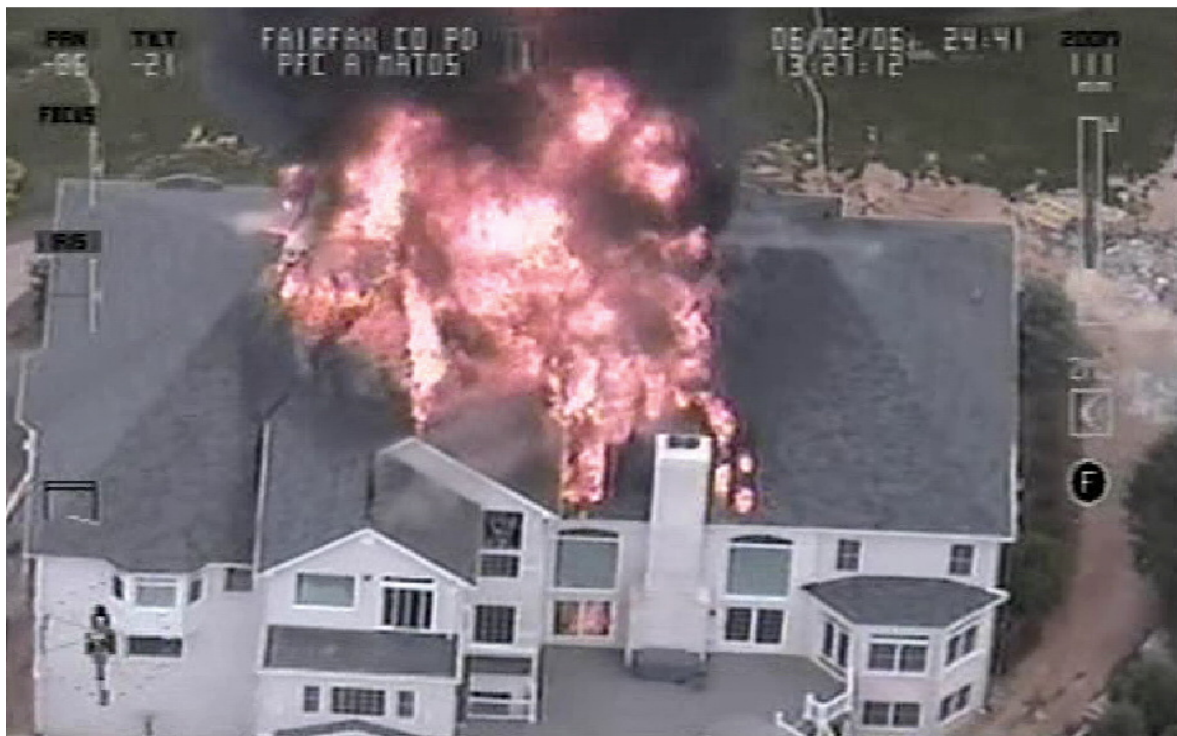
The initial collapse occurred in and around the foyer and stairs. This area had the largest truss span in the building and was located below where the bulk of the fire was venting through the roof. In addition to the large open area, a very large chandelier was suspended from the ceiling in the foyer.

Views of sides A and C from Fairfax County Police Helicopter 'Fairfax One' immediately following the collapse. Fairfax One has been overhead for approximately 10 minutes, BC402 and E434 have been on the scene for approximately 5 minutes.

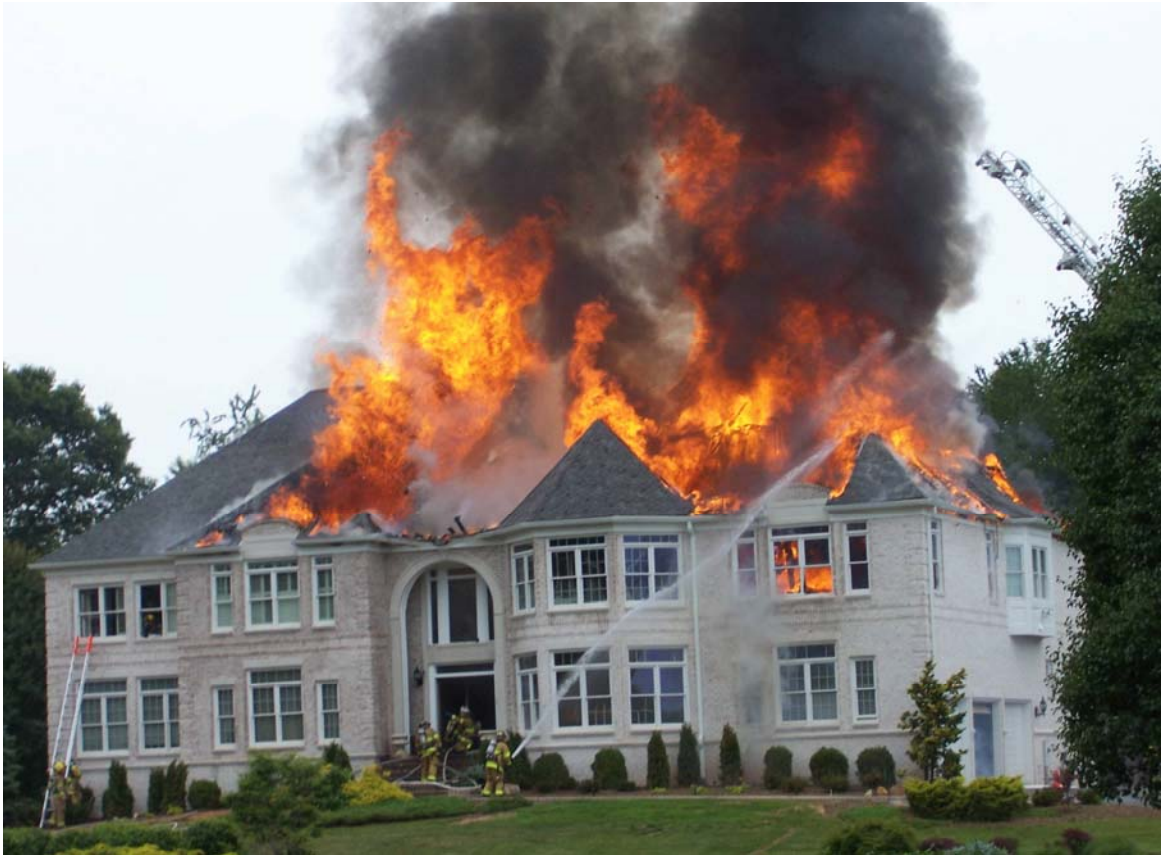
View from the street of the house prior to E434 exiting the structure.

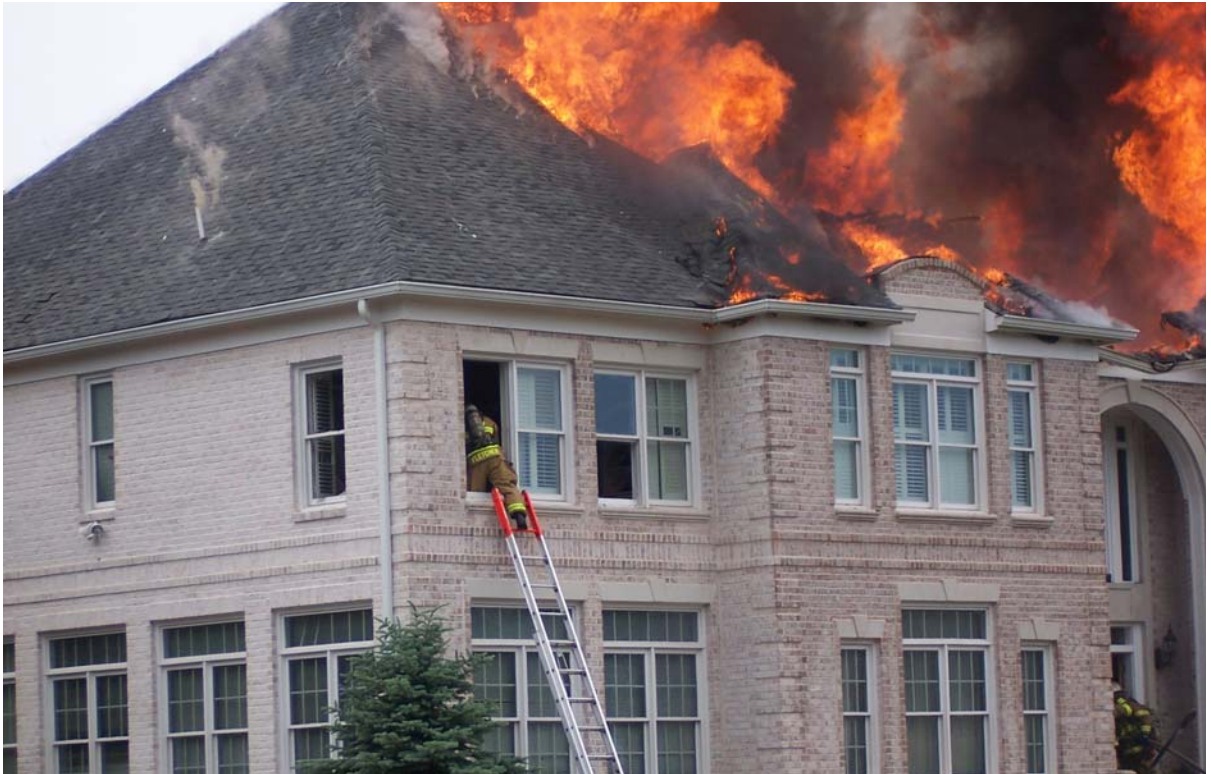
Crewmember from E434 exits the second floor via 24-foot ladder.

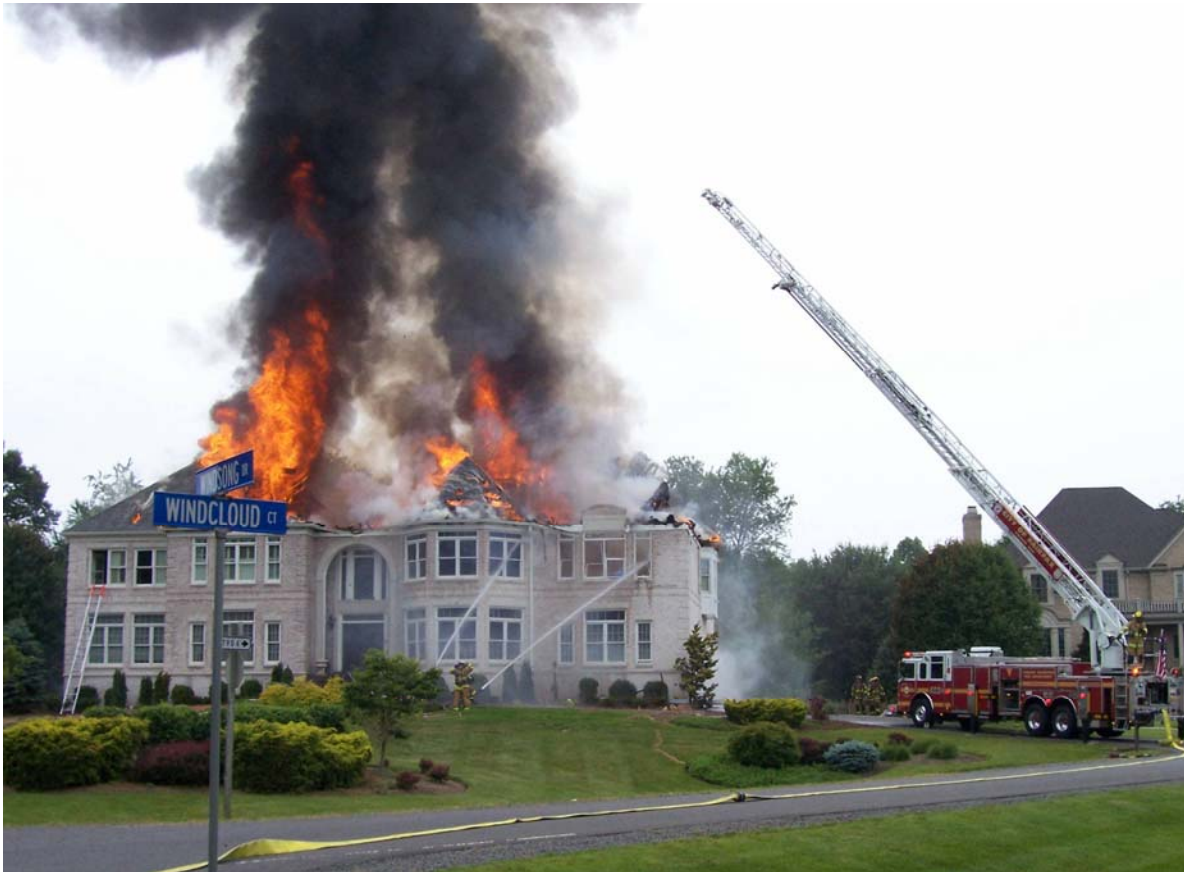
T403 prepares to operate the ladder pipe.
