Impact of Modern Construction Practices on  
Fire Fighter Line of Duty Deaths:

An analytical review of NIOSH LODD reports 1997-2009

International Society of Fire Service Instructors  
And  
Eastern Kentucky University's  
Fire and Safety Engineering Technology Program

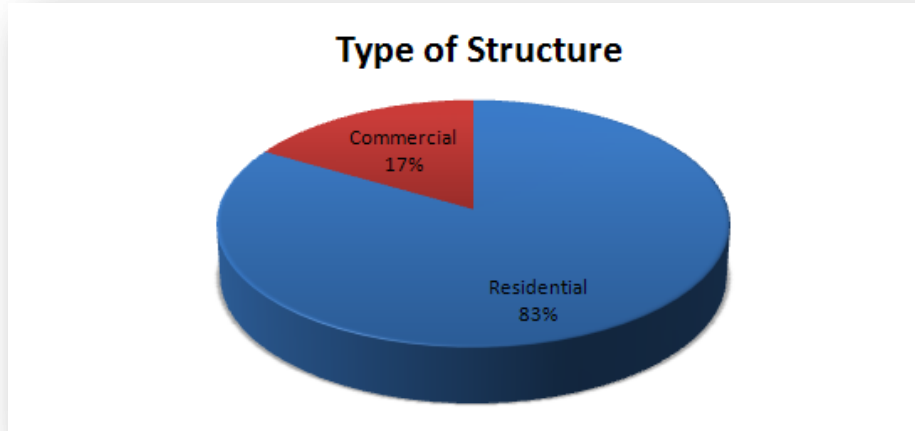
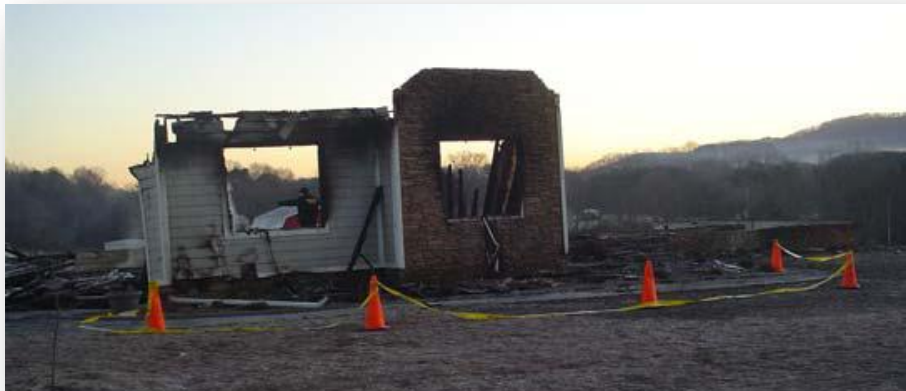
*Image from the January 26, 2007, fire that claimed Volunteer Firefighter Shane Daughtee (NIOSH Report 2007-07)*

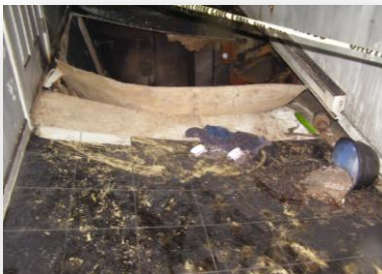
*Image of the hole into which a firefighter fell, claiming his life, following the failure of engineered wood I-joists. (NIOSH Report 2006-24)*

### **Fire departments should ensure that fire fighters performing fire fighting operations under or above trusses are evacuated as soon as it is determined that the trusses are exposed to fire**

Firefighters and command staff having a knowledge of fire behavior is critical, but also knowledge and understanding of the effects of flame impingement on light weight construction components is important. Based on this knowledge, Officers will have a better understanding of when to stay and fight and when to evacuate.
