## **AFTER ACTION INCIDENT REPORT**

*July 3, 2009*

*Structure Fire*

*Two Exposures*

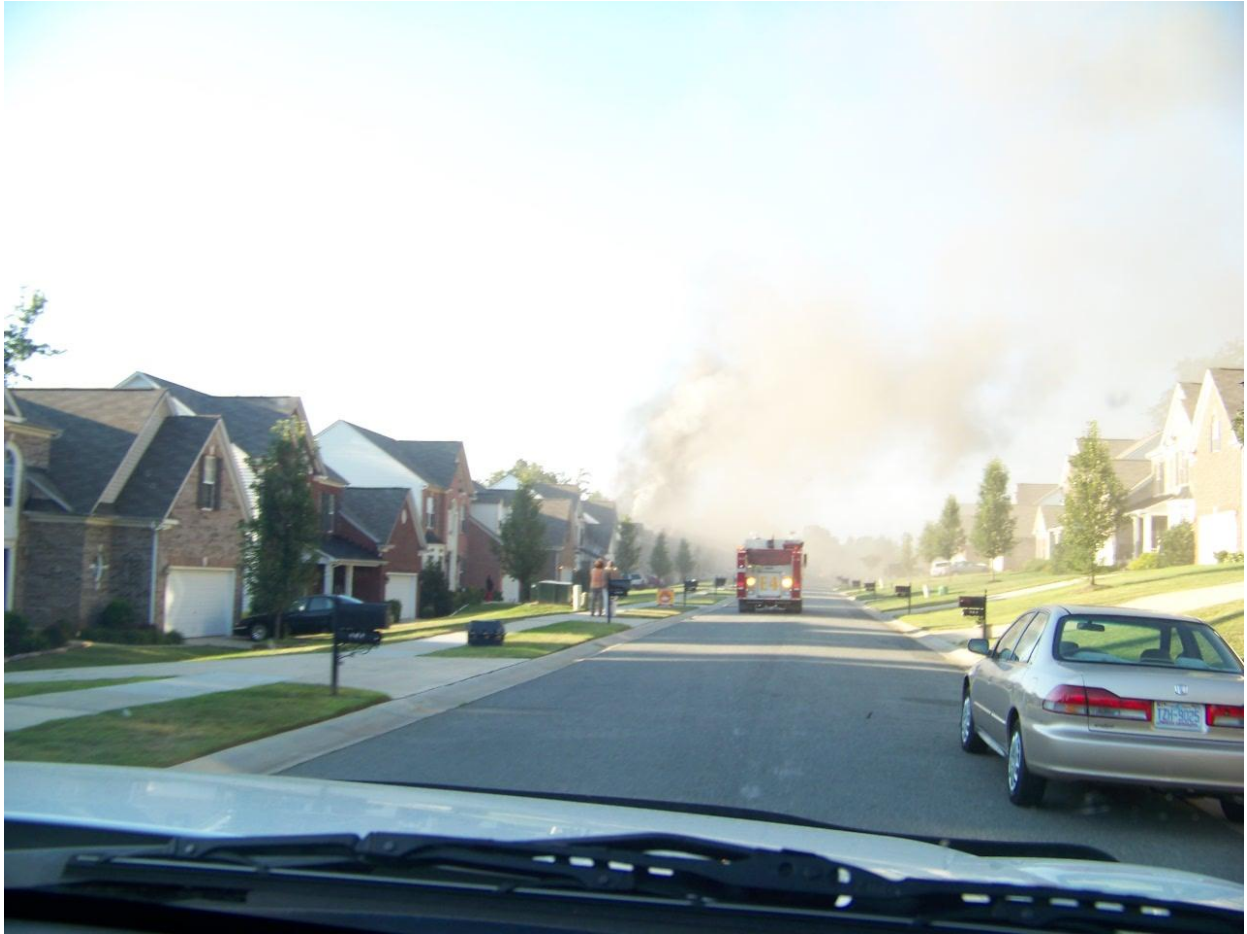
Engine 1's Captain conducted a walk around of the structure and transmitted to command that there appeared to be a fire on the deck that had traveled up the siding into the attic, with a small fire present on the exterior. Engine 1's three personnel advanced a dry hose-line to the second floor of the structure. No smoke or flame was visible on the second floor. Engine 3's four personnel advanced the back-up line to the second floor to assist Engine 1. All personnel donned their SCBA and called for water on the attack lines prior to opening the attic. Battalion 1 advised the interior crews that the fire in the attic had evolved into a full blown attic fire. Smoke conditions on the exterior were changing rapidly with the interior conditions still light smoke and clear visibility.

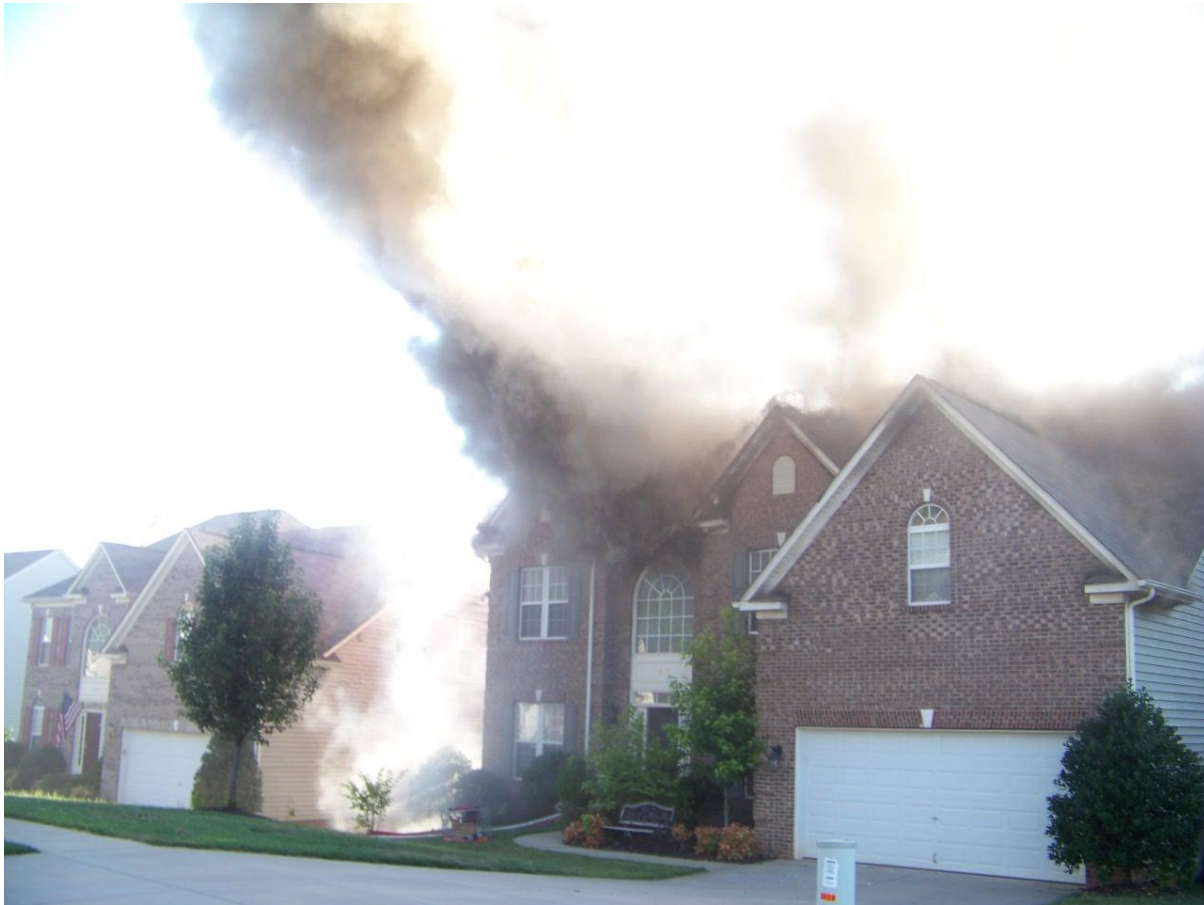
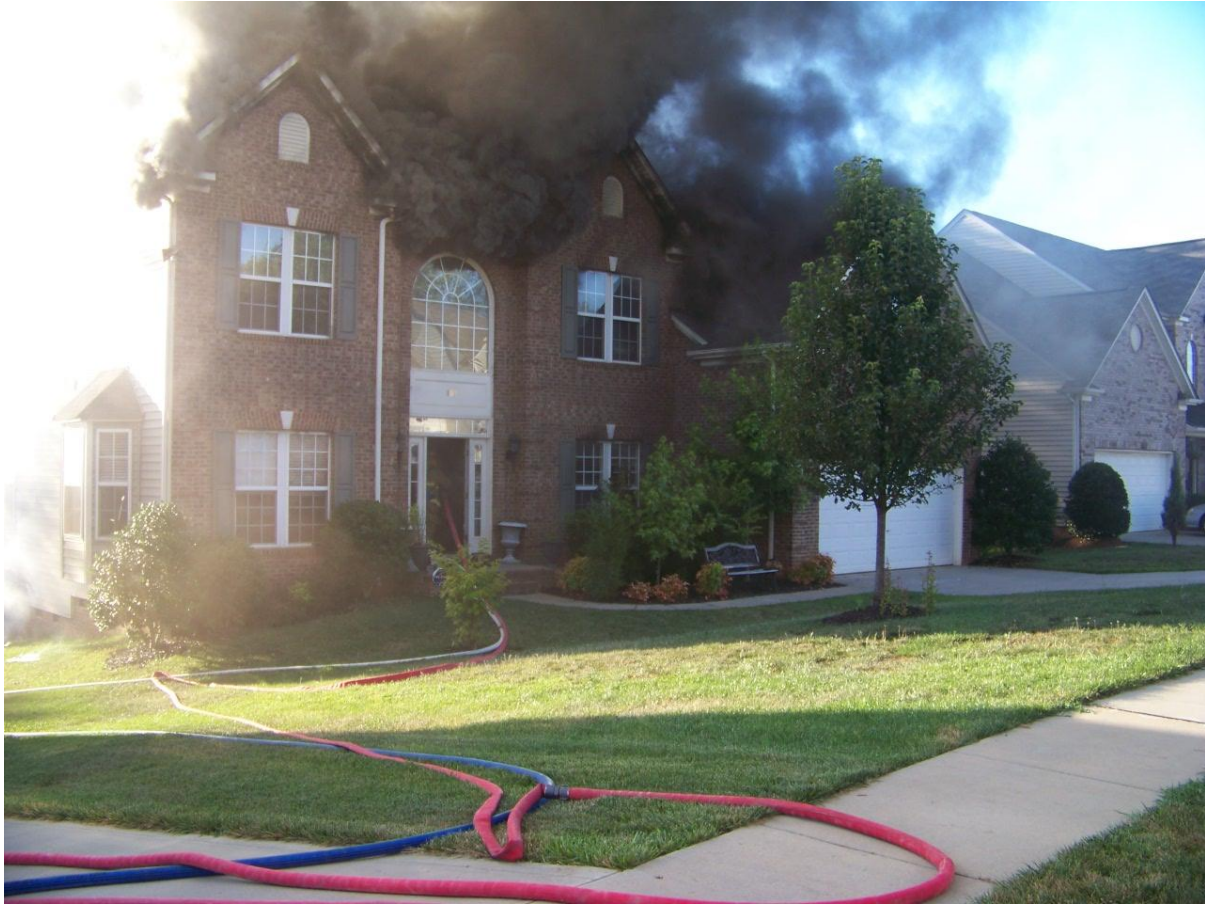
crews to exit the structure. Fire and heavy smoke conditions were present and conditions were changing fast on the exterior. Conditions changed, in a matter of 2 minutes or less, from light smoke to heavy fire, smoke and heat.

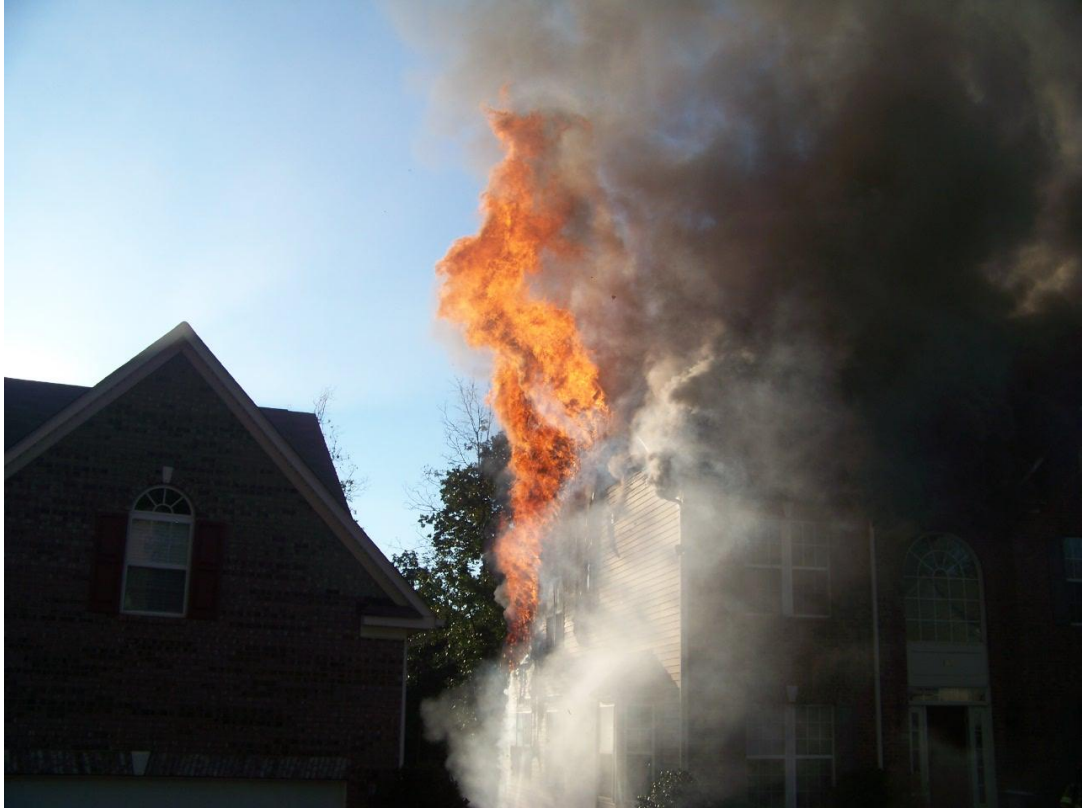
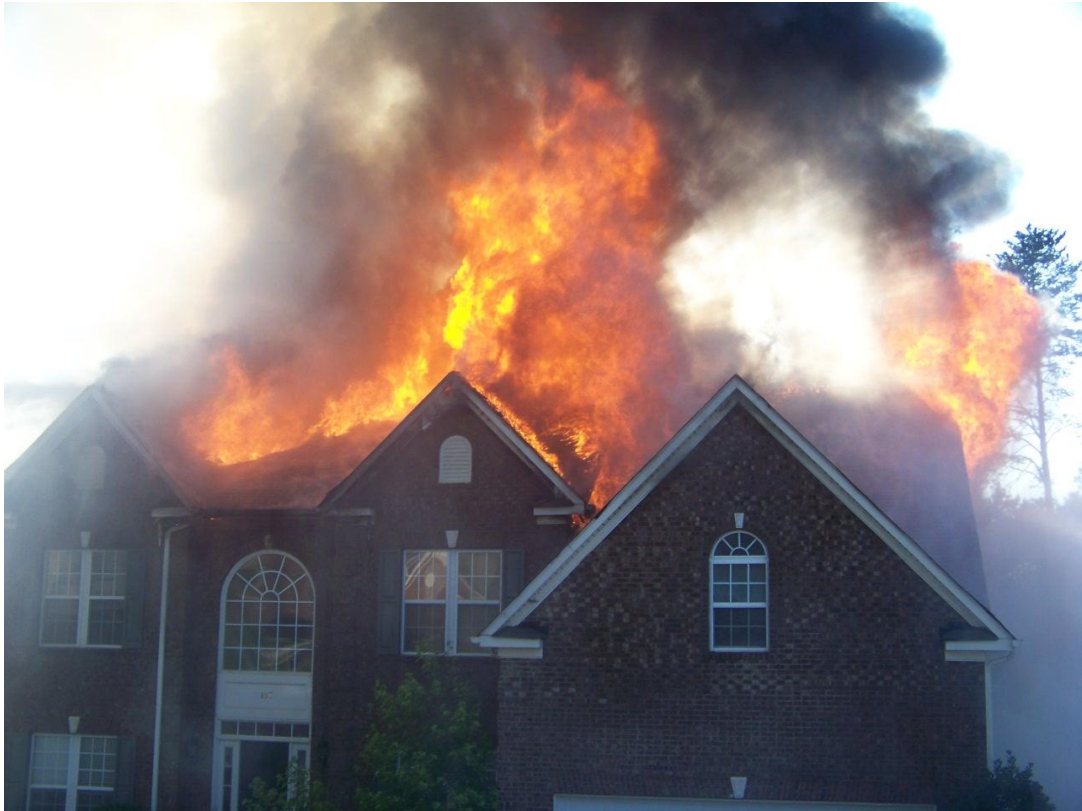
Conditions changed so fast that the firefighters had to leave behind hose lines, axes, thermal imaging cameras and radio equipment. From the time firefighters arrived on scene to the time evacuation was complete was only 6 minutes. The interior conditions went from clear visibility to heavy fire and smoke conditions, over running crews in 2 minutes. Immediately upon exiting the structure, Engine 1 (3 personnel) and Engine 3 (4 personnel) contacted command and gave a Personal Accountability Report (PAR) with their crews. Battalion 1 advised Chief LaCount that the Personnel Accountability Report was confirmed and that all units were out of the structure. Command 1 assumed command and Battalion 1 was transferred to Operations at that time. Operations advised crews to deploy handlines and Engine 1's deck gun onto the exposures.

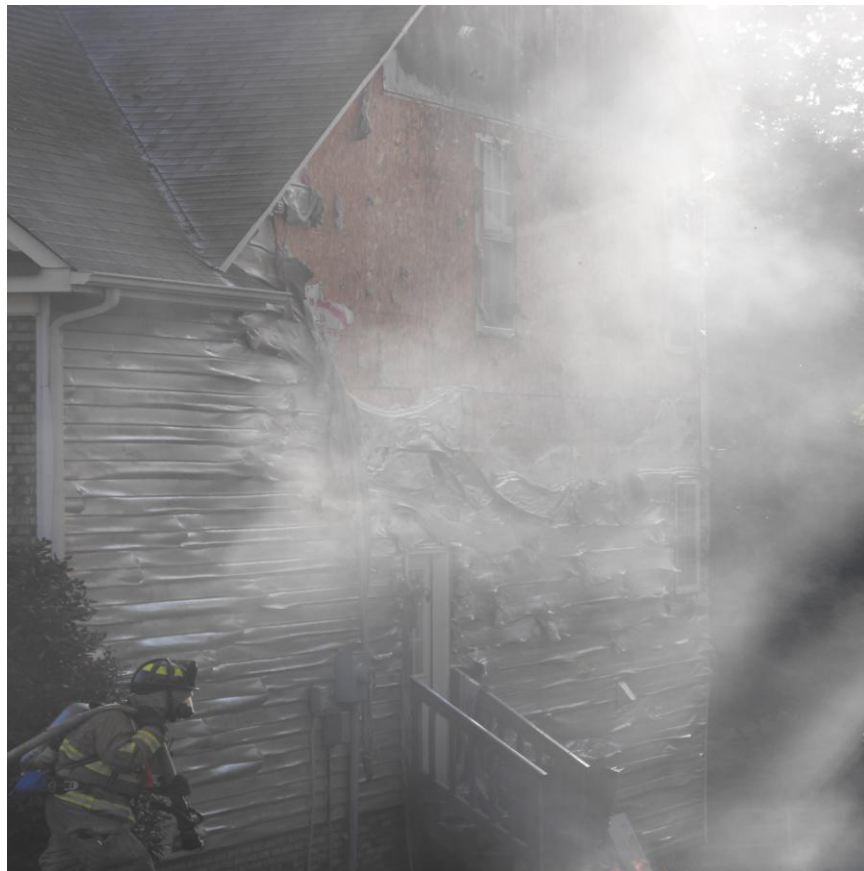
Tower 1 was deploying outriggers and raising the Tower Bucket. Operations assigned Tower 1 to fire suppression of the main structure and all other crews were to protect and extinguish the two exposures. Tower 1 was staffed with 2 personnel (instead of the usual 3), which dramatically contributed to a delay in deploying the Tower bucket for fire suppression. The Tower requires a minimum of 2 persons in the bucket in order to operate the ladder and operate the two nozzles. Utilizing this bucket/ladder with one person in the bucket is not a safe operation. It decreases the effectiveness that this person can have on a fire. One person in the bucket and one person on the turn-table increases the time frame required to set-up the Tower for operation. Tower 1 made a knockdown on the main fire and all other crews maintained the exposures. Exposure B suffered fire development on the interior of the attic along with fire ignition to the side of the house. Exposure C experienced ignition to the exterior of the structure.
