## Structural Collapse: The Hidden Dangers of Residential Fires

By James M. Dalton, Robert G. Backstrom, and Steve Kerber

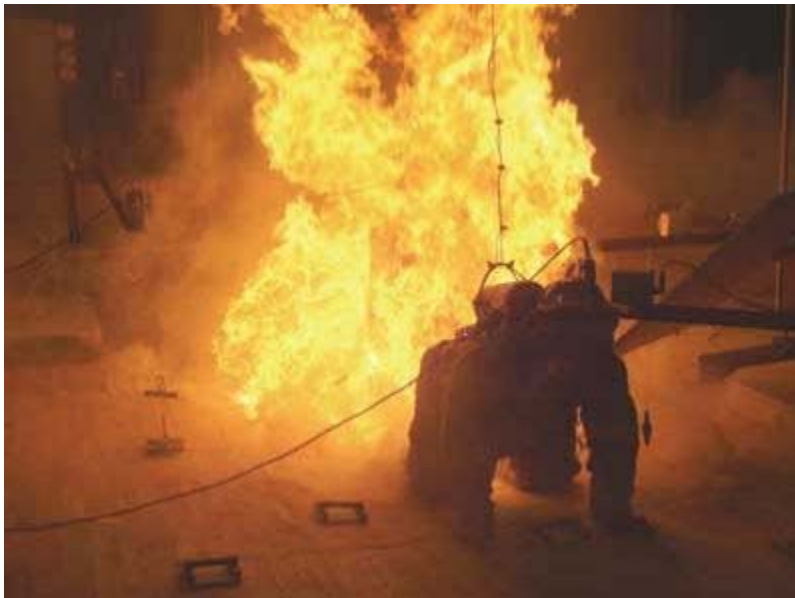
(1) A standing firefighter mannequin is engulfed in flames as he falls through the floor assembly behind the crawling firefighter mannequin. (Photos courtesy of authors.)

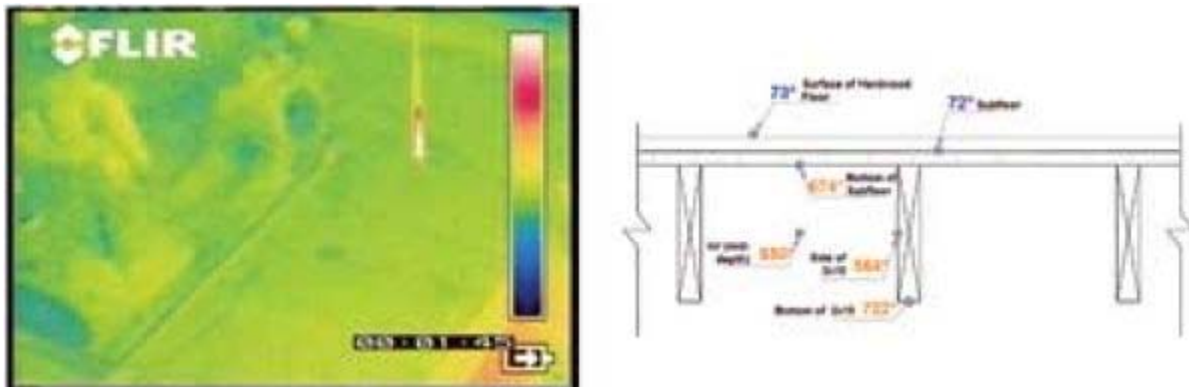
(3) Thermal imaging camera image and temperature measurement of legacy 2 x 10 joist floor—without ceiling at 1:45. Left: The thermal imaging camera view. Right: Temperature measurements above and below the finished flooring.

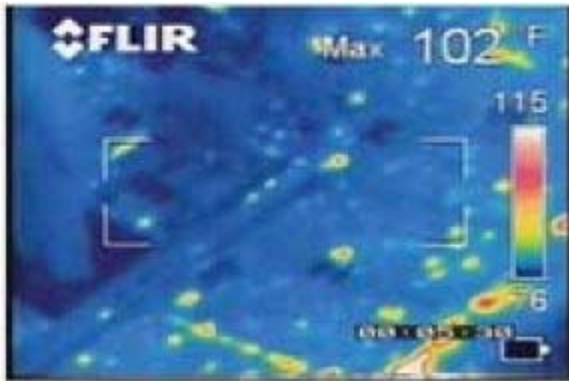
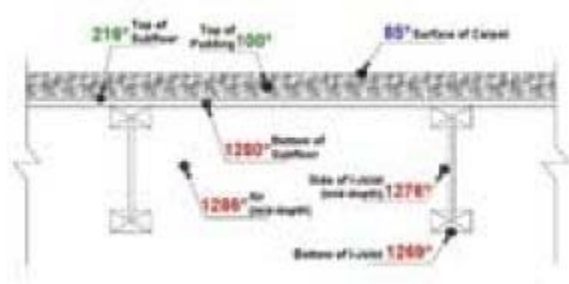
(4) Thermal imaging camera image and temperature measurement of modern lightweight 12-inch wood I-Joist floor—without ceiling at 5:30, just prior to the floor collapse. Left: The thermal imaging camera view. Right: Temperature measurements above and below the finished flooring.

**Thermal imaging cameras do not provide an adequate indication of a weakened floor or pending collapse.** There is a potentially dangerous misconception in the fire service that TICs can detect fire on the floor below or above a firefighter. TICs detect variations in surface temperatures for objects in the field of vision. They cannot detect temperatures if the camera is thermally shielded by the finish materials of a floor or ceiling, such as carpet or gypsum board. Average temperatures below the assembly were in excess of 1,200°F while average temperatures on top of the carpet were less than 100°F. The application of water during suppression operations will also further mask these thermal signatures in the TIC camera's field of vision during suppression operations.

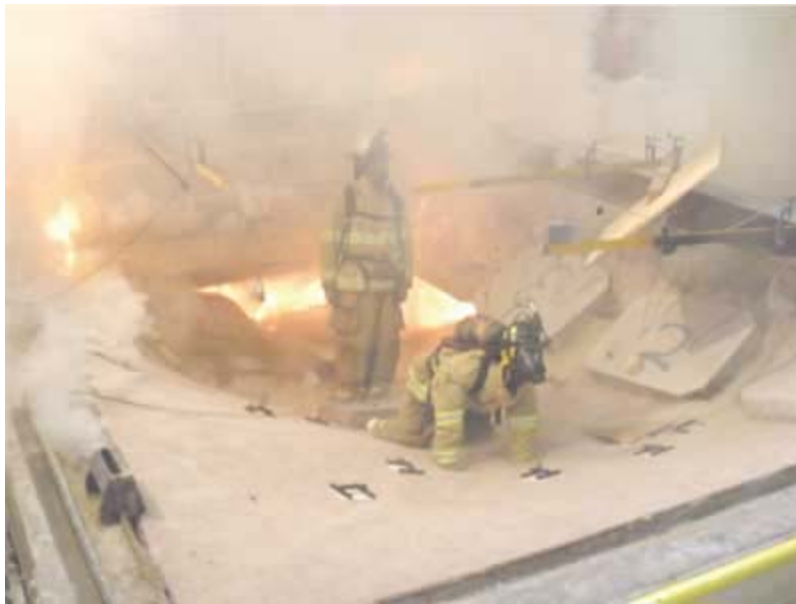
(5) A modern lightweight 12-inch wood I-joint floor—without ceiling. Collapse Time = 06:03. (5) The excessive floor deflections at the time of failure. (6) The condition of one of the surviving engineered I-joists after extinguishment.

A review of the ASTM E119 and ISO 834:1 failure times as they apply to the unprotected (without ceiling) engineered wooden I-joint assembly clearly illustrates that the floor had become significantly damaged and lost its ability to carry load far before the actual total collapse time. If the ISO standard was applied to the unprotected engineered wooden I-joint assembly, the accepted failure time would change from 06:03 (acceptance criteria time per the ASTM E119 standard) to 04:00 (load-bearing capacity per the ISO 834:1 standard). For the fire service, this means that a complete collapse of this floor would have been seen at 06:03 but that the floor would have been severely compromised and potentially unsafe to operate on at 04:00. Be aware that although these testing methods provide documented research failure times, they also illustrate that the floors have become dangerous far before the actual documented collapse times. This trend was consistent throughout the engineered lumber assemblies tested within this study. These failures in real-life incidents may also be accelerated by larger fire loads and variations in field conditions.

This research project demonstrated that adding a single layer of 1/2-inch gypsum wall board to the bottom of the unprotected floor assembly regardless of legacy or modern construction, a standard method of passive fire protection, can add on average approximately 20 minutes to the collapse time. The addition of passive fire protection requirements in the model building codes for these construction assemblies would protect not only the lives of the first responders, but would provide for the safe egress of the building occupants as well.

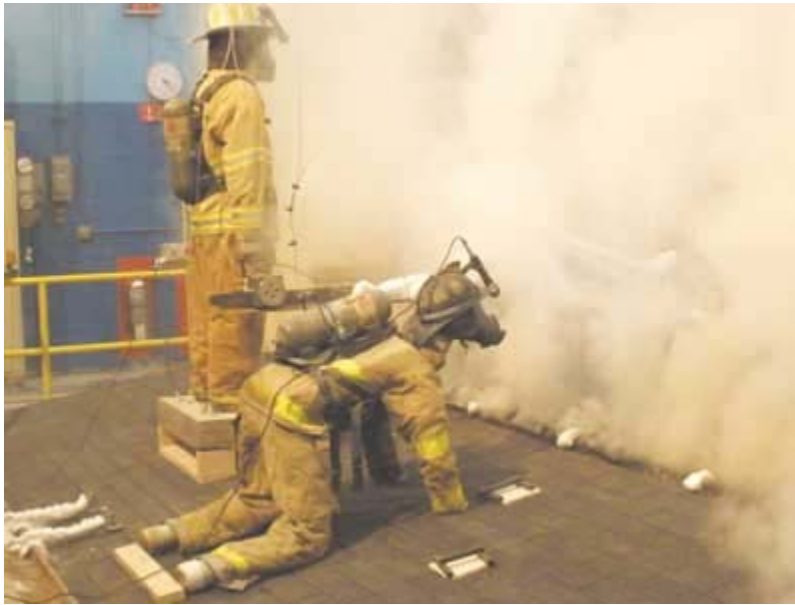
Modern lightweight metal gusset truss roof—with ceiling.  
Collapse Time = 23:15. (7) A significant volume and velocity of smoke during initial portions of the test.

The study, however, did demonstrate a potentially dangerous and misleading ventilation phenomenon regarding installed roof vents. Initially, there was a significant amount of smoke emitting from the continuous plastic ridge vent at the beginning of the modern roof assembly test. As the temperatures increased, the continuous plastic ridge vent melted and collapsed. The collapse of the vent changed the ventilation profile for the roof. The initially heavy smoke pattern emitting from the continuous ridge vent diminished to a light indistinguishable smoke trail, although the fire was still raging below. The excessive heat created by the fire was, in effect, restricted from venting vertically through existing natural openings and created an excessively untenable condition below the roof in the attic and the occupied floor areas below the attic as the ceiling finishes failed.

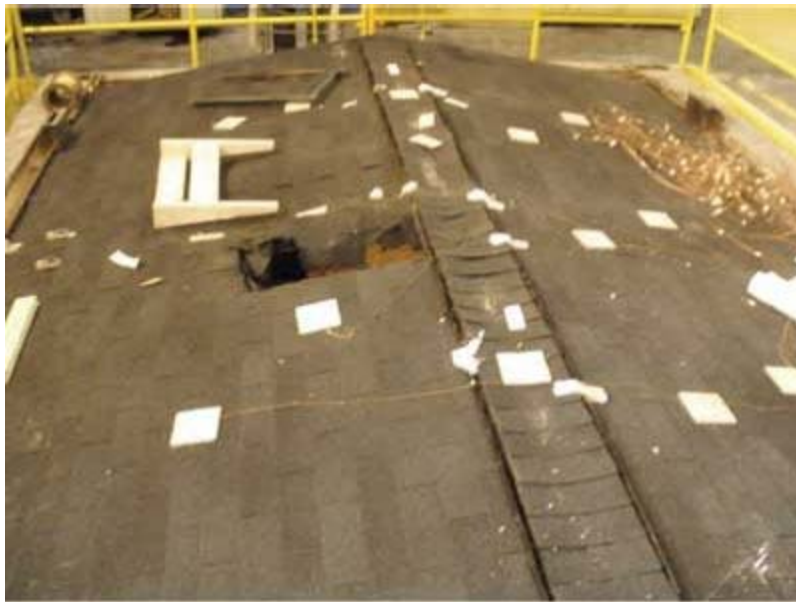
(8) The collapse of the continuous plastic ridge vent.

Teams conducting size-up prior to fireground operations may be deceived by this change in the quantity and velocity of the smoke emitting from the roof structure as they prepare to conduct fireground operations. A confined unventilated fire in an enclosed attic will accelerate the failure of roof structural elements and contribute to the failure of the ceiling materials between the attic and floors below.

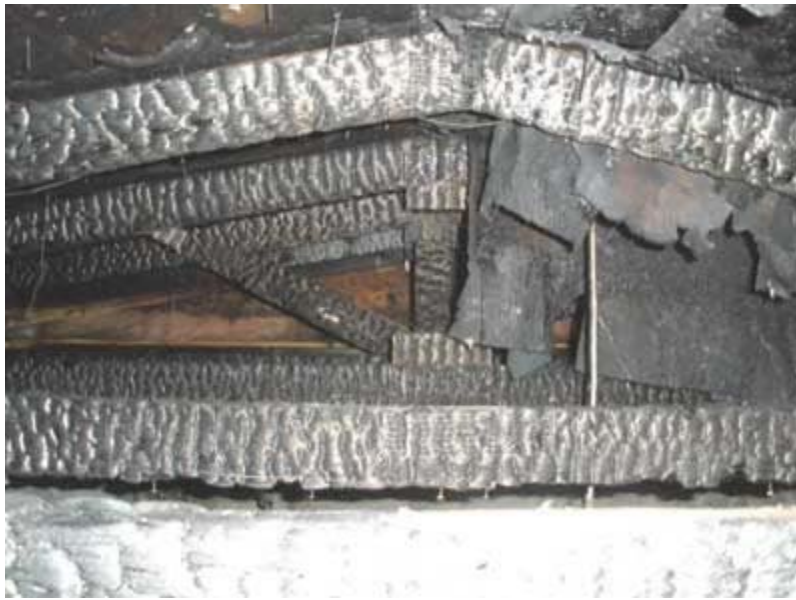
Modern lightweight metal gusset truss roof—with ceiling. Collapse Time = 23:15. (9) Multiple metal gusset plate and web member failures.

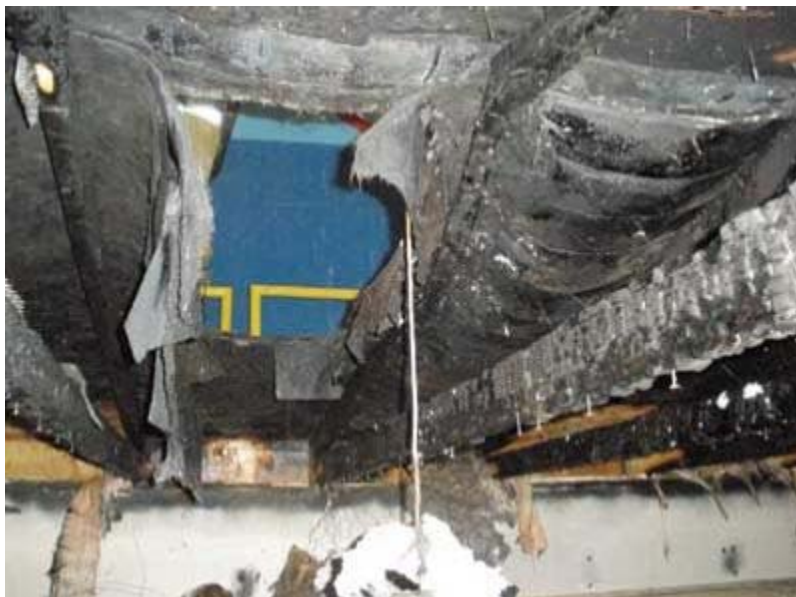
## (10) The deterioration of roof sheathing and ultimate failure of the roof sheathing and shingle materials.
