## **AFTER ACTION INCIDENT REPORT**

*July 3, 2009*

*Structure Fire*

*Two Exposures*

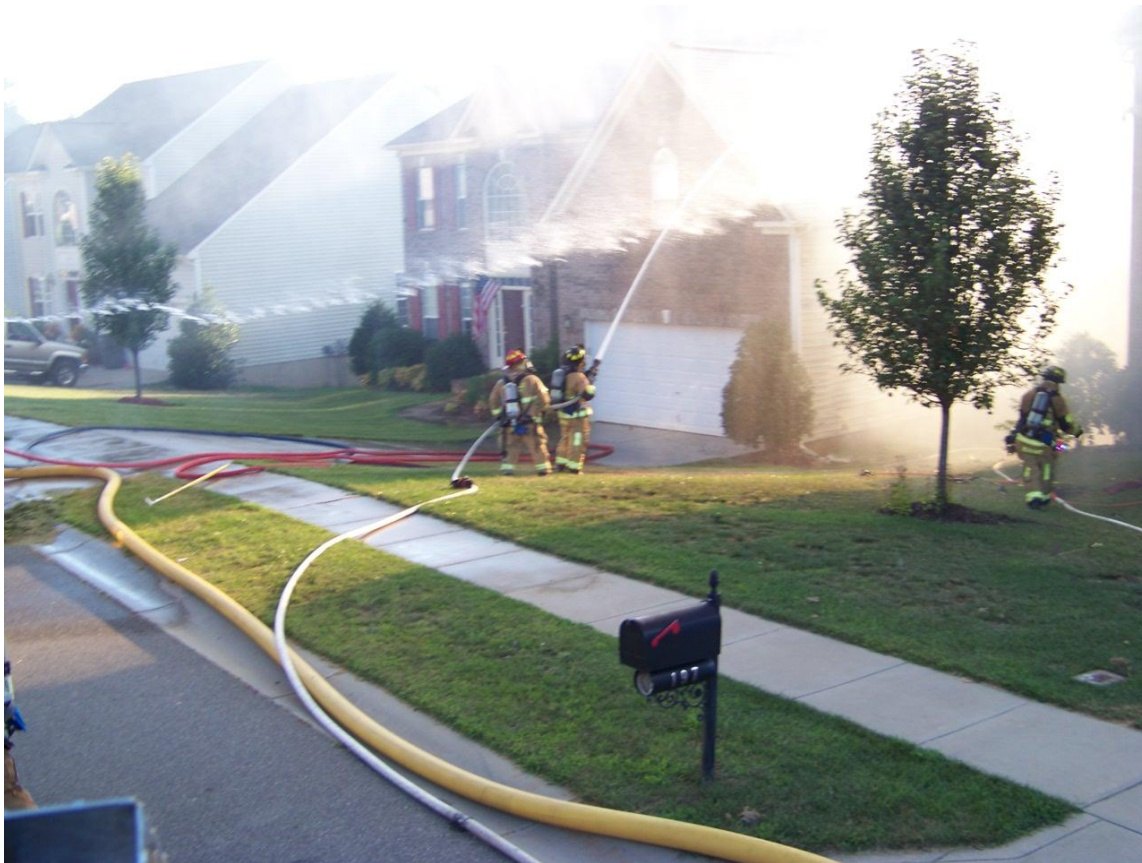
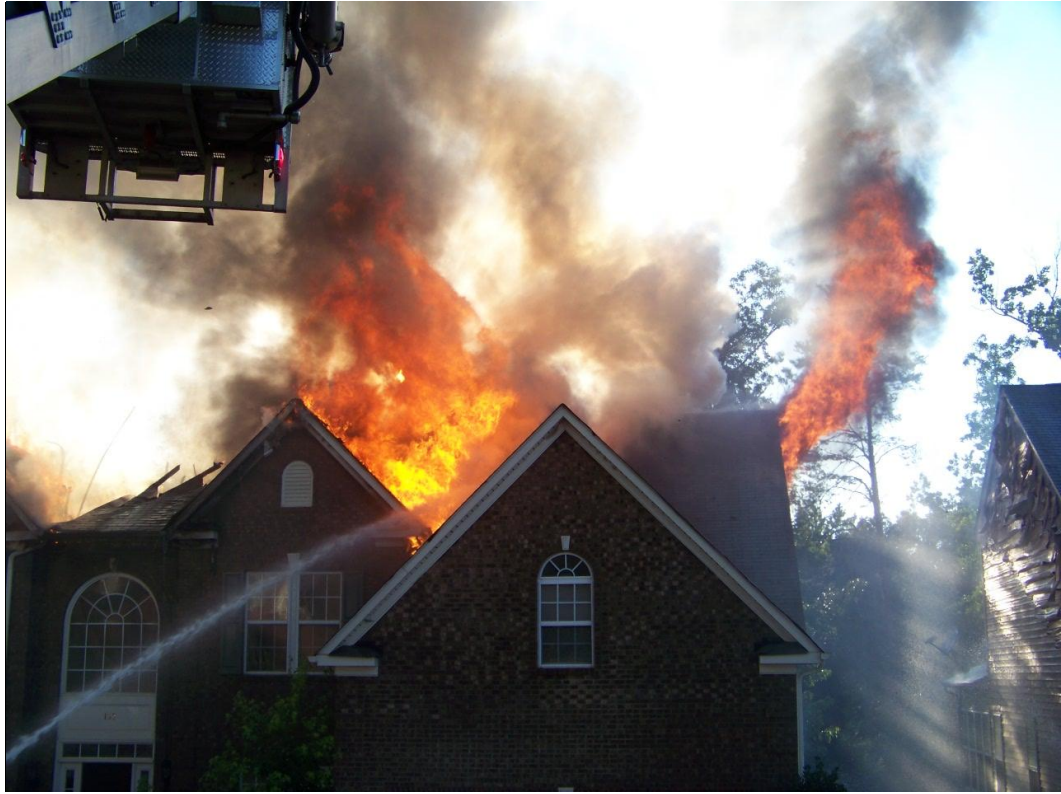
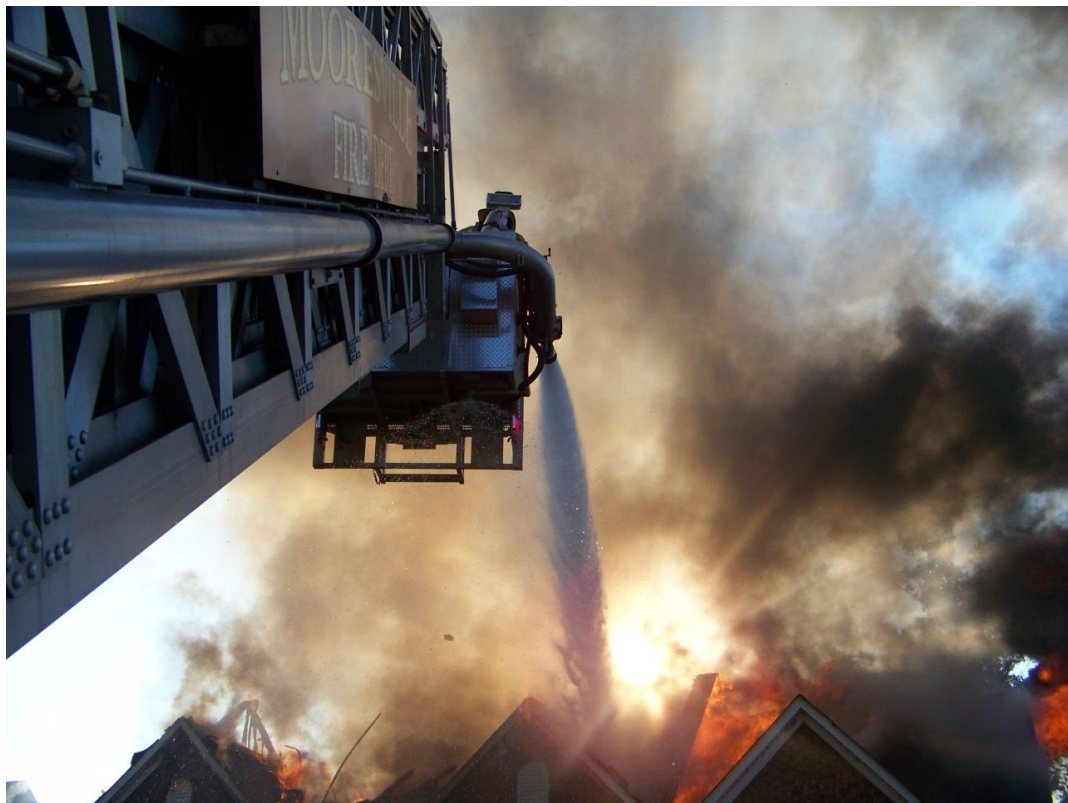
Conditions changed so fast that the firefighters had to leave behind hose lines, axes, thermal imaging cameras and radio equipment. From the time firefighters arrived on scene to the time evacuation was complete was only 6 minutes. The interior conditions went from clear visibility to heavy fire and smoke conditions, over running crews in 2 minutes. Immediately upon exiting the structure, Engine 1 (3 personnel) and Engine 3 (4 personnel) contacted command and gave a Personal Accountability Report (PAR) with their crews. Battalion 1 advised Chief LaCount that the Personnel Accountability Report was confirmed and that all units were out of the structure. Command 1 assumed command and Battalion 1 was transferred to Operations at that time. Operations advised crews to deploy handlines and Engine 1's deck gun onto the exposures.

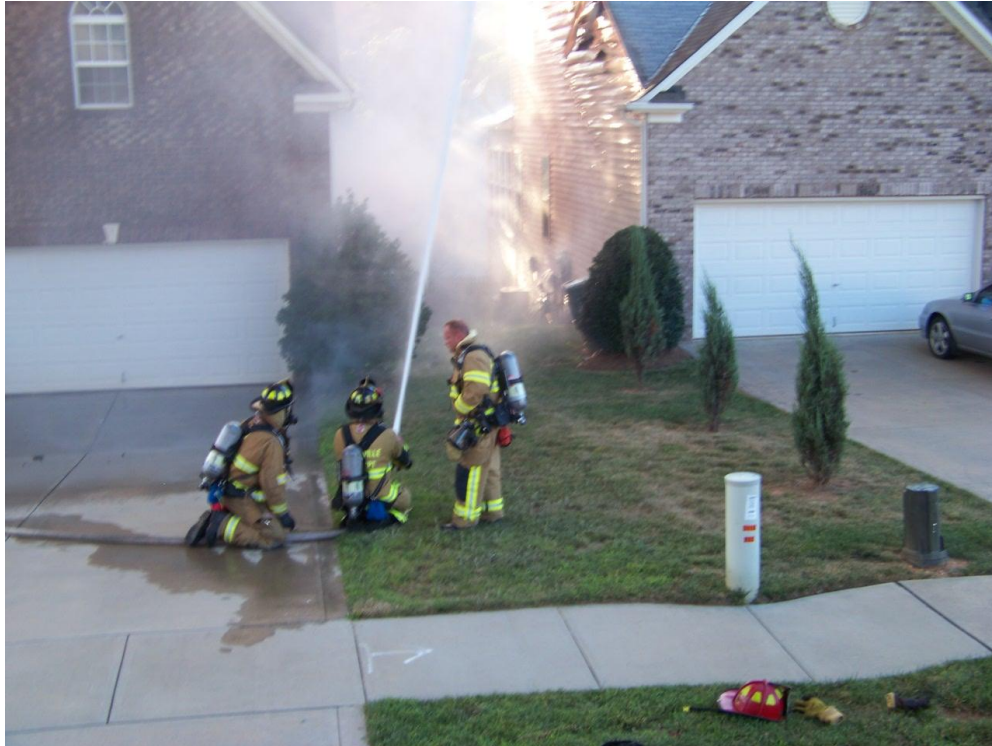
Tower 1 was deploying outriggers and raising the Tower Bucket. Operations assigned Tower 1 to fire suppression of the main structure and all other crews were to protect and extinguish the two exposures. Tower 1 was staffed with 2 personnel (instead of the usual 3), which dramatically contributed to a delay in deploying the Tower bucket for fire suppression. The Tower requires a minimum of 2 persons in the bucket in order to operate the ladder and operate the two nozzles. Utilizing this bucket/ladder with one person in the bucket is not a safe operation. It decreases the effectiveness that this person can have on a fire. One person in the bucket and one person on the turn-table increases the time frame required to set-up the Tower for operation. Tower 1 made a knockdown on the main fire and all other crews maintained the exposures. Exposure B suffered fire development on the interior of the attic along with fire ignition to the side of the house. Exposure C experienced ignition to the exterior of the structure.

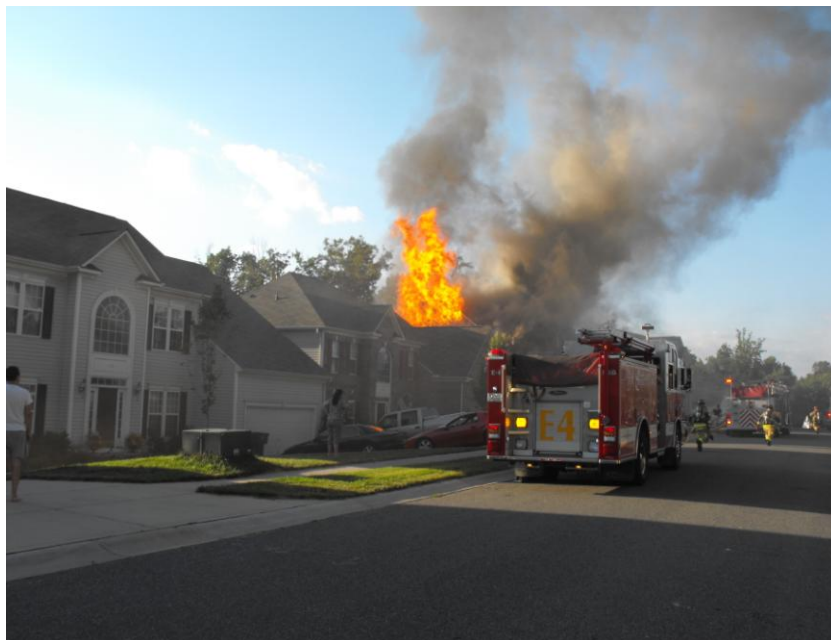
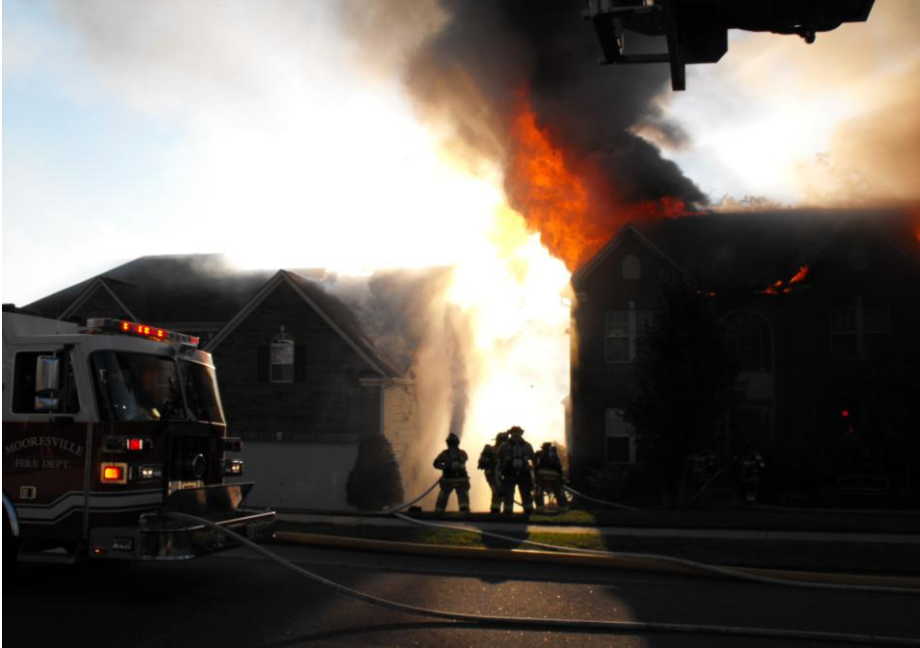
The Fire Marshal's office arrived on scene and conducted a fire investigation. Overhaul and Salvage operations were conducted, and the last crew cleared the scene at 3:30am July 4<sup>th</sup>, 2009. An incident briefing was conducted on all three shifts immediately following the fire.
