# Structural Collapse: The Hidden Dangers of Residential Fires

By James M. Dalton, Robert G. Backstrom, and Steve Kerber

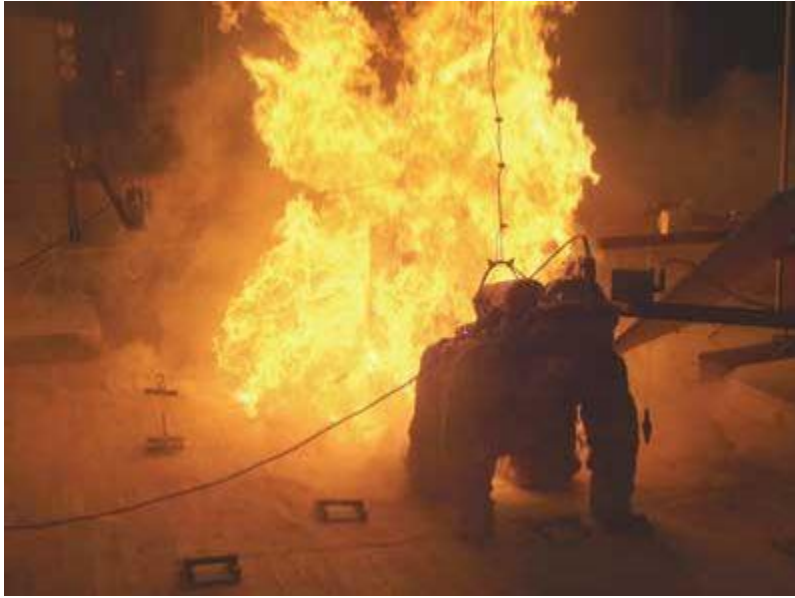
(1) A standing firefighter mannequin is engulfed in flames as he falls through the floor assembly behind the crawling firefighter mannequin. (Photos courtesy of authors.)

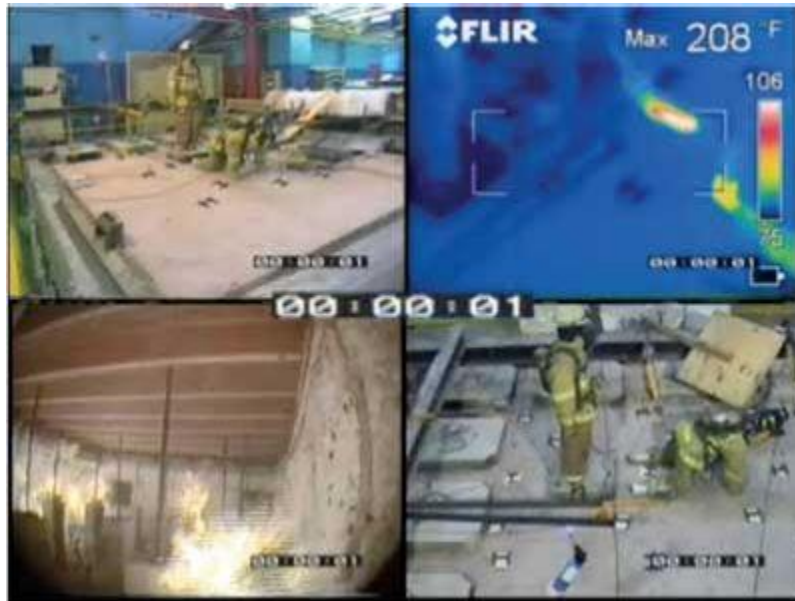
(2) A quadrant view of recorded video images taken during the experiments available in the Web-based outreach program.

All of this information could not be included in a single article or report, so it has been developed into a Web-based outreach program for the fire service. This free interactive program is at [www.ul.com/fire/structural.html](http://www.ul.com/fire/structural.html).

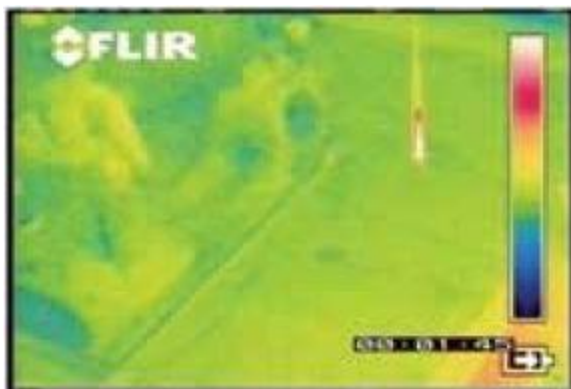
(3) Thermal imaging camera image and temperature measurement of legacy 2 x 10 joist floor—without ceiling at 1:45. Left: The thermal imaging camera view. Right: Temperature measurements above and below the finished flooring.

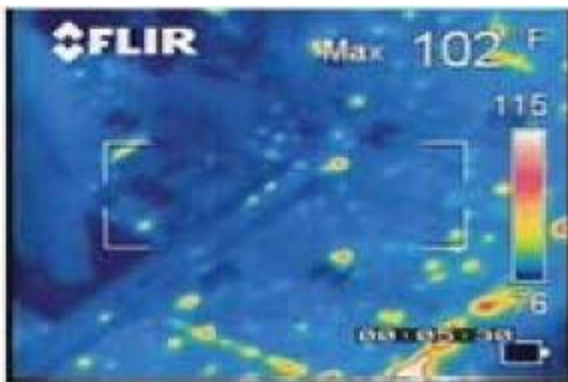
(4) Thermal imaging camera image and temperature measurement of modern lightweight 12-inch wood I-Joist floor—without ceiling at 5:30, just prior to the floor collapse. Left: The thermal imaging camera view. Right: Temperature measurements above and below the

finished flooring.

**Thermal imaging cameras do not provide an adequate indication of a weakened floor or pending collapse.** There is a potentially dangerous misconception in the fire service that TICs can detect fire on the floor below or above a firefighter. TICs detect variations in surface temperatures for objects in the field of vision. They cannot detect temperatures if the camera is thermally shielded by the finish materials of a floor or ceiling, such as carpet or gypsum board. Average temperatures below the assembly were in excess of 1,200°F while average temperatures on top of the carpet were less than 100°F. The application of water during suppression operations will also further mask these thermal signatures in the TIC camera’s field of vision during suppression operations.

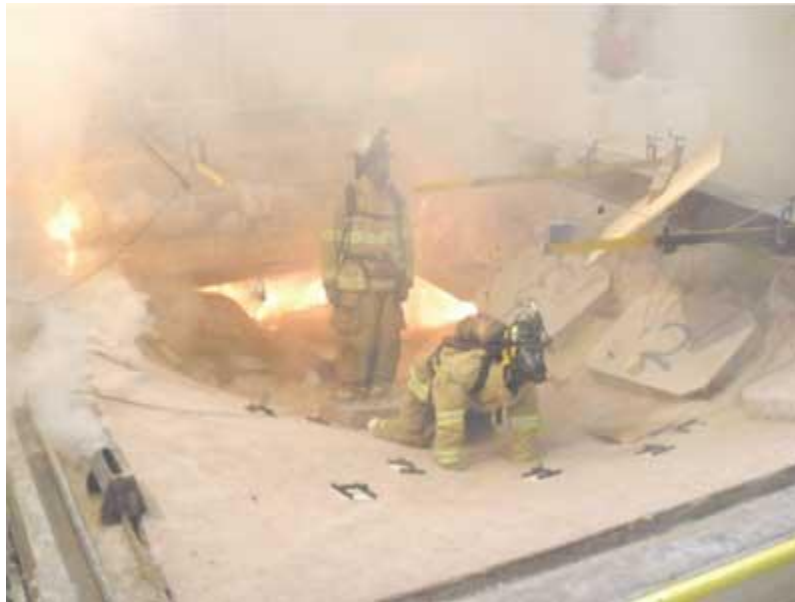
(5) A modern lightweight 12-inch wood I-joint floor—without ceiling. Collapse Time = 06:03. (5) The excessive floor deflections at the time of failure. (6) The condition of one of the surviving engineered I-joists after extinguishment.

A review of the ASTM E119 and ISO 834:1 failure times as they apply to the unprotected (without ceiling) engineered wooden I-joint assembly clearly illustrates that the floor had become significantly damaged and lost its ability to carry load far before the actual total collapse time. If the ISO standard was applied to the unprotected engineered wooden I-joint assembly, the accepted failure time would change from 06:03 (acceptance criteria time per the ASTM E119 standard) to 04:00 (load-bearing capacity per the ISO 834:1 standard). For the fire service, this means that a complete collapse of this floor would have been seen at 06:03 but that the floor would have been severely compromised and potentially unsafe to operate on at 04:00. Be aware that although these testing methods provide documented research failure times, they also illustrate that the floors have become dangerous far before the actual documented collapse times. This trend was consistent throughout the engineered lumber assemblies tested within this study. These failures in real-life incidents may also be accelerated by larger fire loads and variations in field conditions.

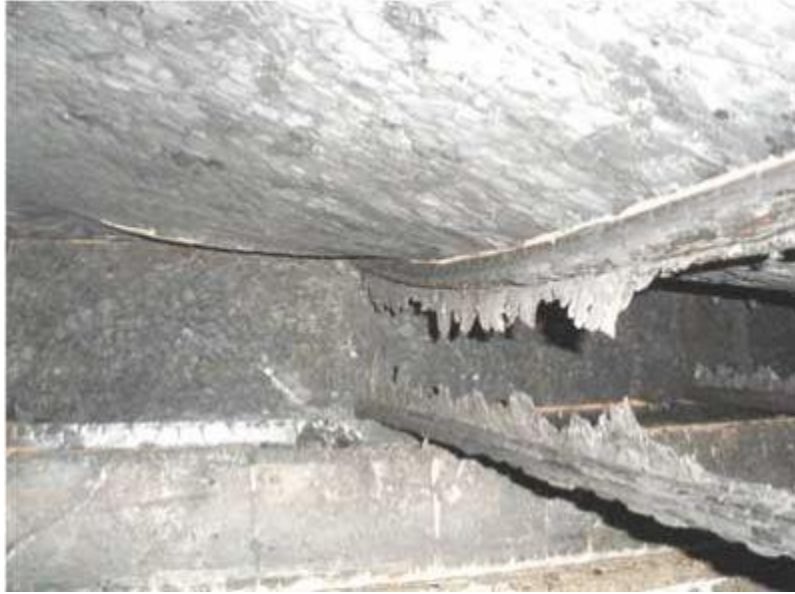
(6) Modern lightweight metal gusset truss roof—with ceiling.  
Collapse Time = 23:15.

**Structural performance of the roof assemblies.** This research also conducted two roof tests respective of finished ceiling/attic assemblies representing both “legacy” and “modern” construction. The evaluation of the structural performance of these assemblies and components was limited because of the available span of the furnace dimensions with respect to the overall depth of the roof structures. This is a significant limitation as the  $2 \times 4$  metal gusset-plated roof trusses can span distances that far exceed 14 feet.

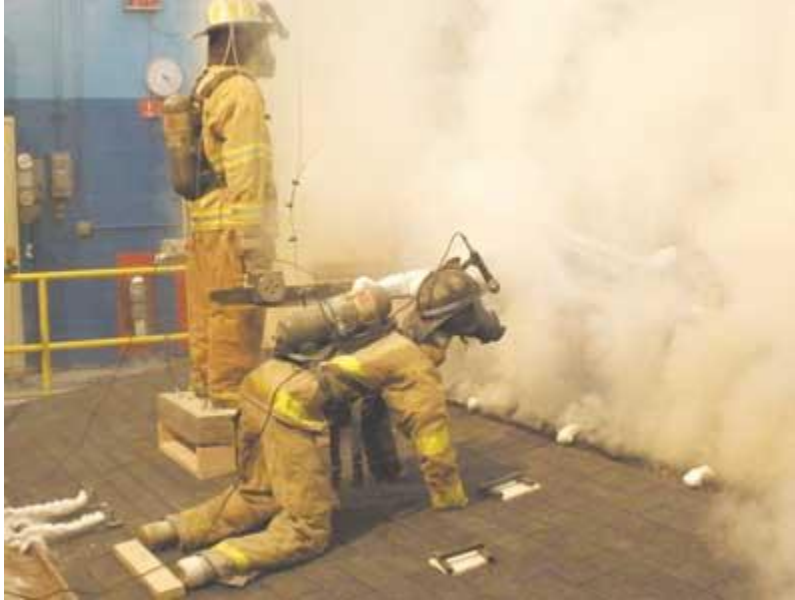
Modern lightweight metal gusset truss roof—with ceiling.  
Collapse Time = 23:15. (7) A significant volume and velocity  
of smoke during initial portions of the test.

The study, however, did demonstrate a potentially dangerous and misleading ventilation phenomenon regarding installed roof vents. Initially, there was a significant amount of smoke emitting from the continuous plastic ridge vent at the beginning of the modern roof assembly test. As the temperatures increased, the continuous plastic ridge vent melted and collapsed. The collapse of the vent changed the ventilation profile for the roof. The initially heavy smoke pattern emitting from the continuous ridge vent diminished to a light indistinguishable smoke trail, although the fire was still raging below. The excessive heat created by the fire was, in effect, restricted from venting vertically through existing natural openings and created an excessively untenable condition below the roof in the attic and the occupied floor areas below the attic as the ceiling finishes failed.

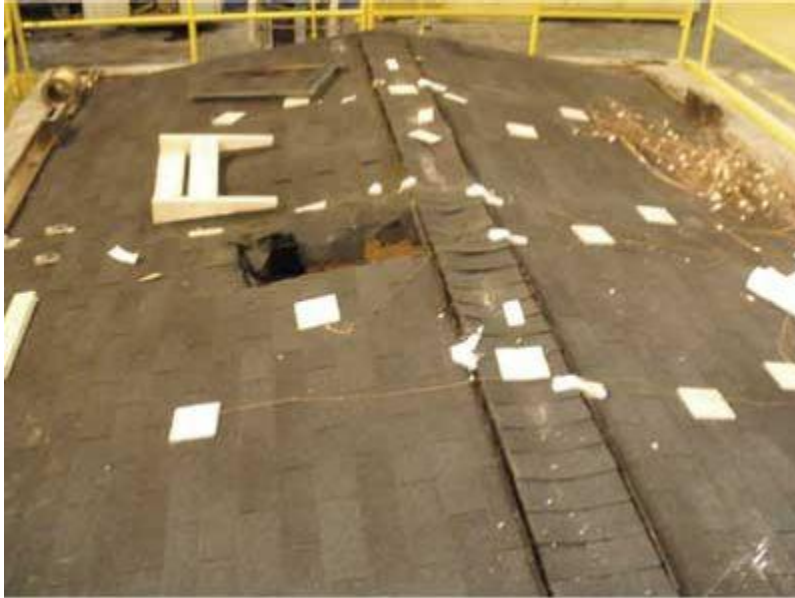
(8) The collapse of the continuous plastic ridge vent.

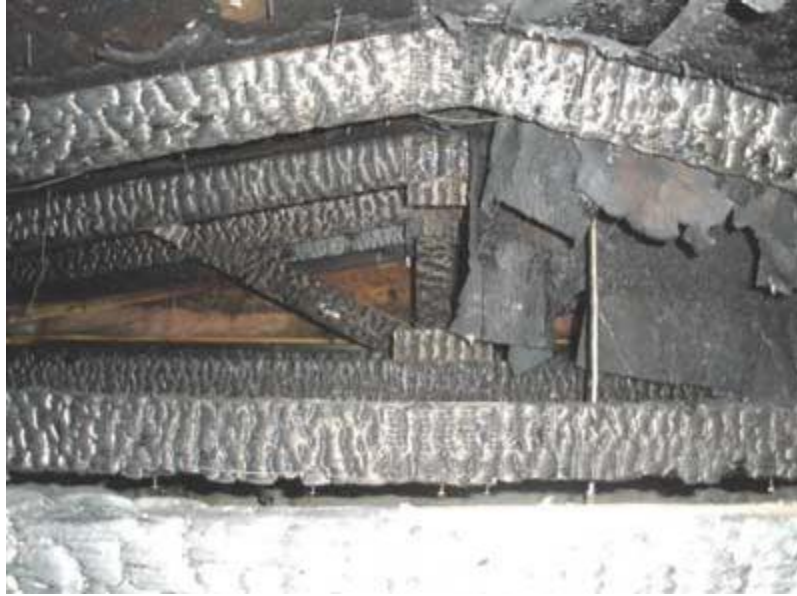
Modern lightweight metal gusset truss roof—with ceiling.  
Collapse Time = 23:15. (9) Multiple metal gusset plate and  
web member failures.

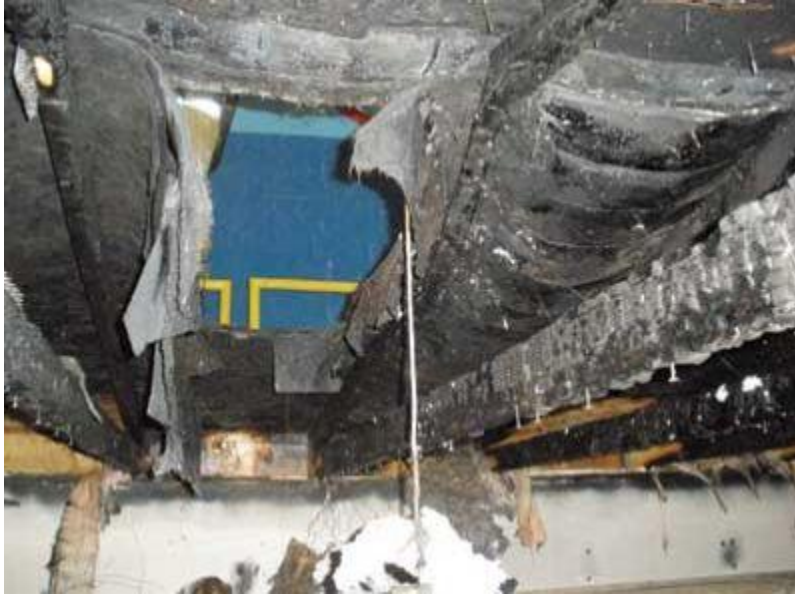
(10) The deterioration of roof sheathing and ultimate failure of the roof sheathing and shingle materials.
